MP 5.0 90' Deck Plate Girder 3 Spans – 33' 3" + 30' + 26' 9" Timber Deck

Mile 4.7 Trail MP 3.7 2nd bridge over Montour Run at Willada

No Builder's Plate evident Bridge reused from original 1879 main line at MP 4.8

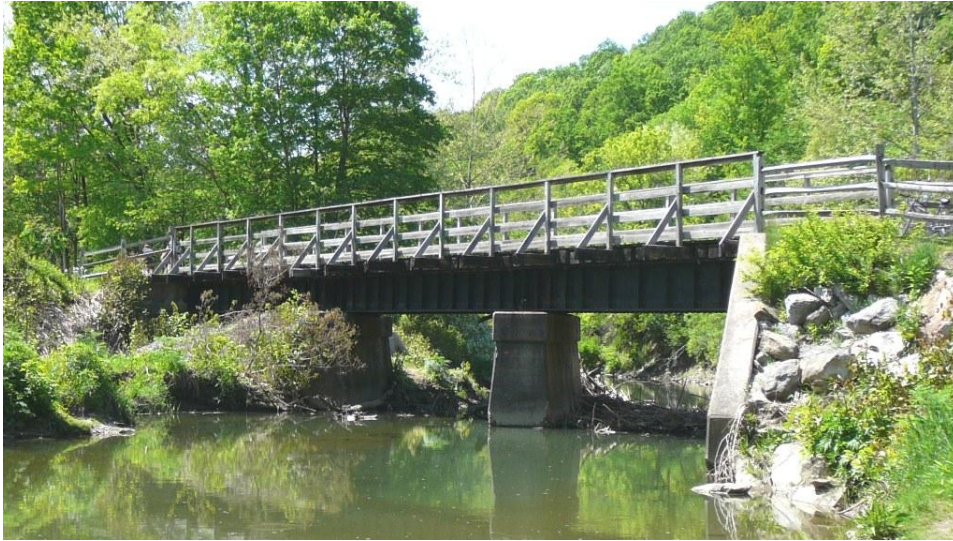
View looking north toward Montour Run Road. 3 spans with 2 concrete piers in Montour Run.

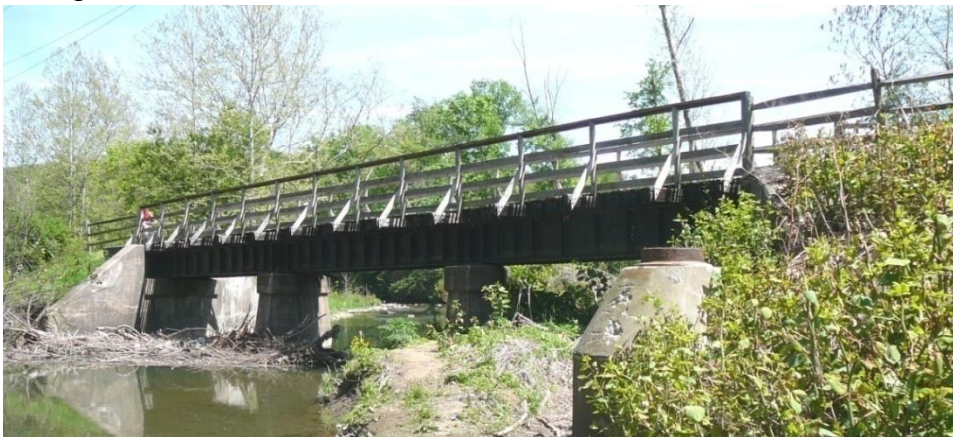
Looking south. Safety railings and fencing were installed by Montour Trail Council during trail construction.

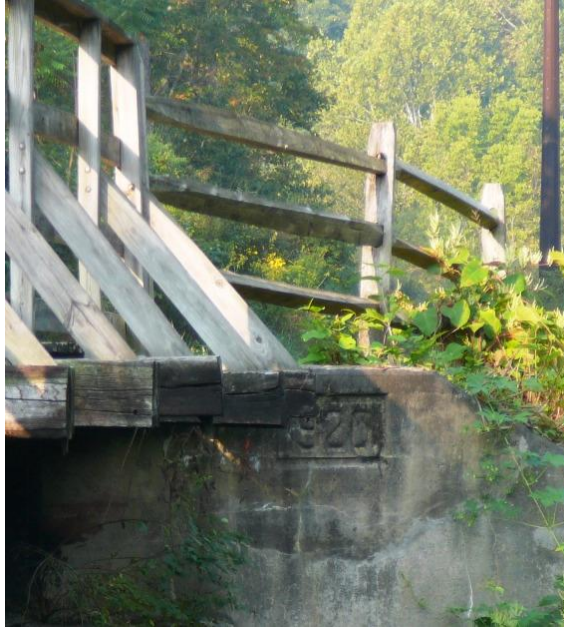
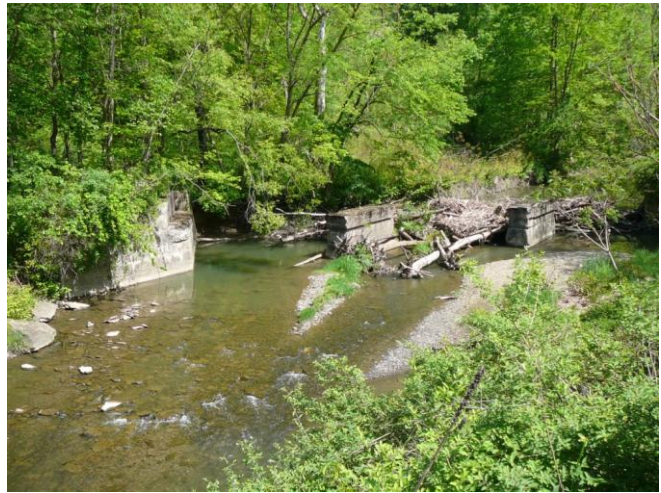
1920 date stamped in concrete abutment. This bridge was reused from the original main line and moved as part of the 1920 realignment project. The bridge was built circa. 1879, on the original Montour Right-of-Way. On Right, the original bridge piers can be seen south of the current bridge at MP 4.8 (Trail milepost 3.5)

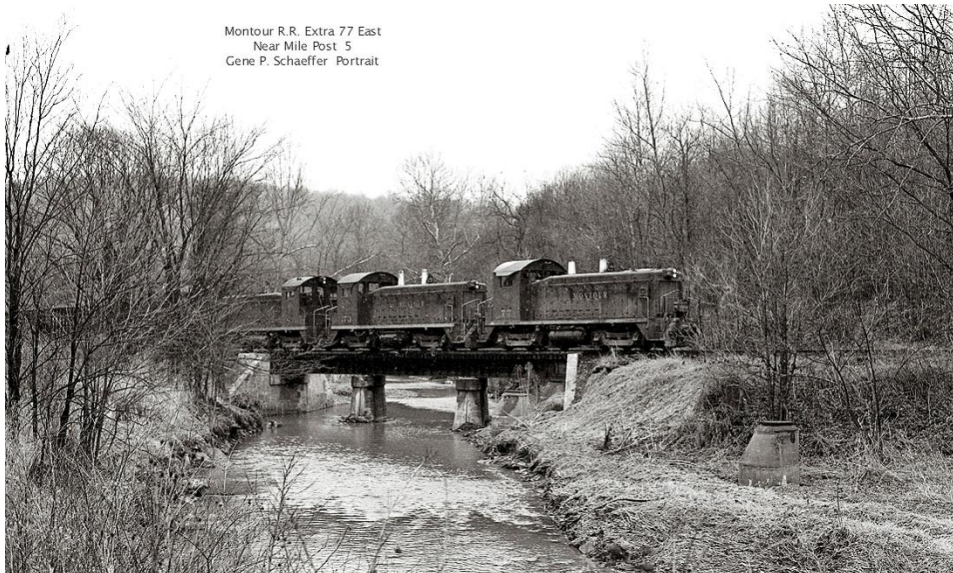
Looking south, as a Montour train of empty coal hoppers crosses the bridge.

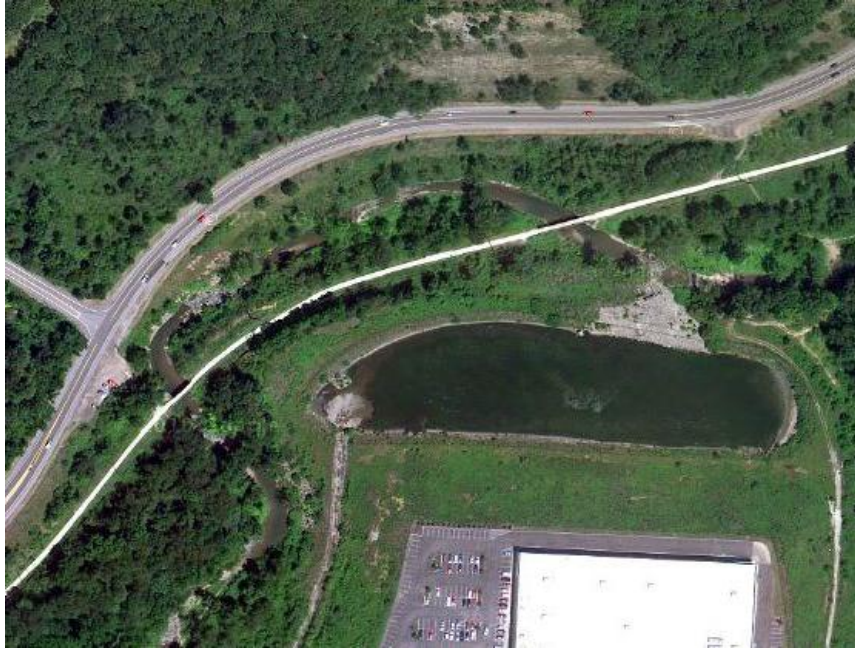
Satellite view shows bridge above and right of center. Montour Run Road runs across frame, with Hookstown Road intersection at left and Costco at bottom right. Montour Run channel was relocated during road construction. In upper left quadrant, the original channel went across roadway at intersection of Hookstown Road and looped around field on opposite side of road, re-crossing road to bridge. Montour Run flows left to right.

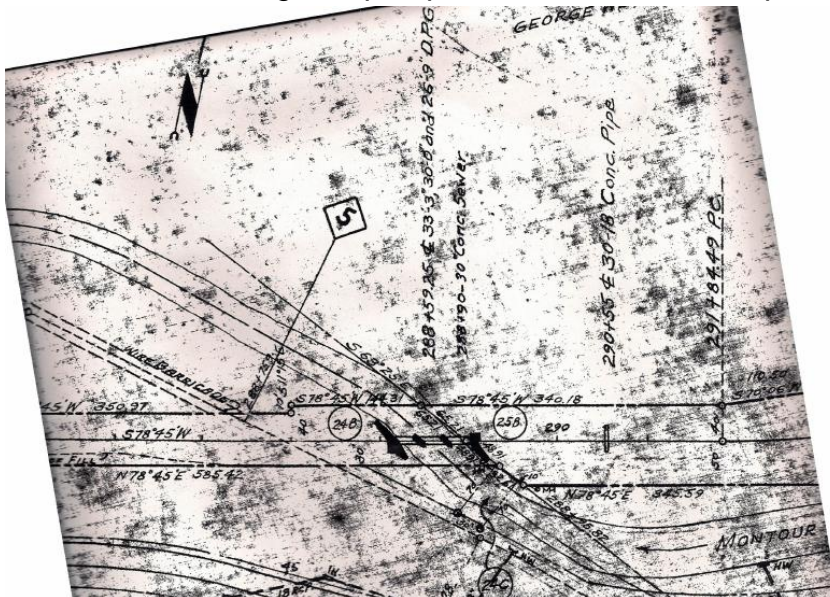
Valuation Plans show bridge with concrete abutments and 2 concrete piers in middle of Montour Run. Length of 3 spans noted at top center. Montour Run Road is at bottom left, with south being at top of plan. Note railroad milepost 5 is shown to left of bridge.

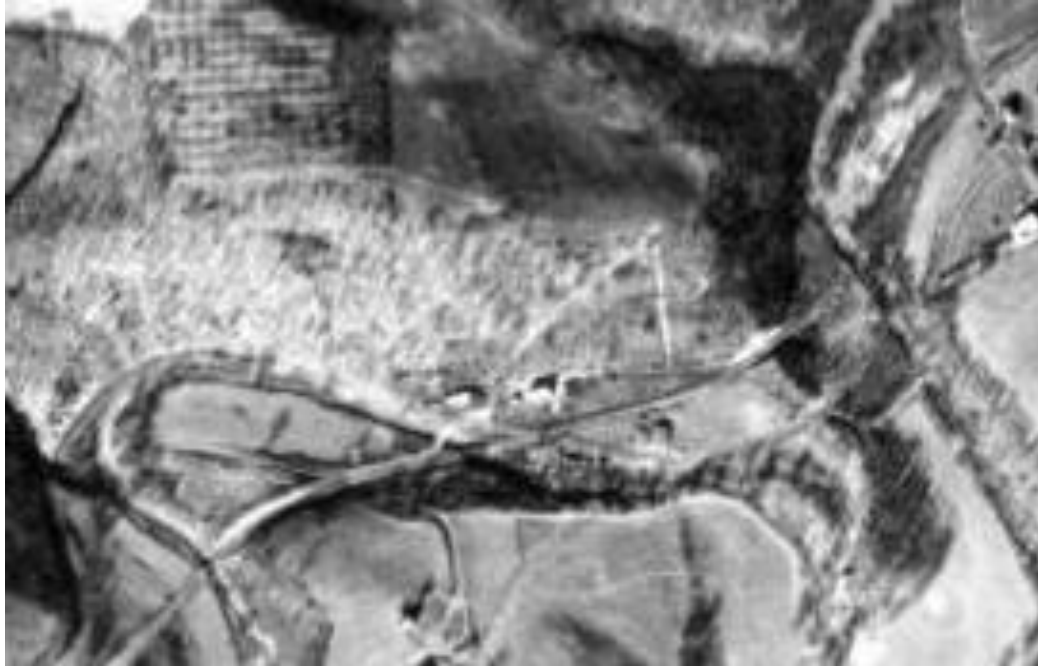
Aerial view in 1938 shows original alignment of main line and realignment including 3 new bridges.

Original Right-of-Way diverges at top right, near farm road – then curves to follow Montour Run along loop at left of center and rejoins Right-of-Way at bottom left. This bridge, the 2nd of 3 in this realignment project, is just below & left of center of picture.

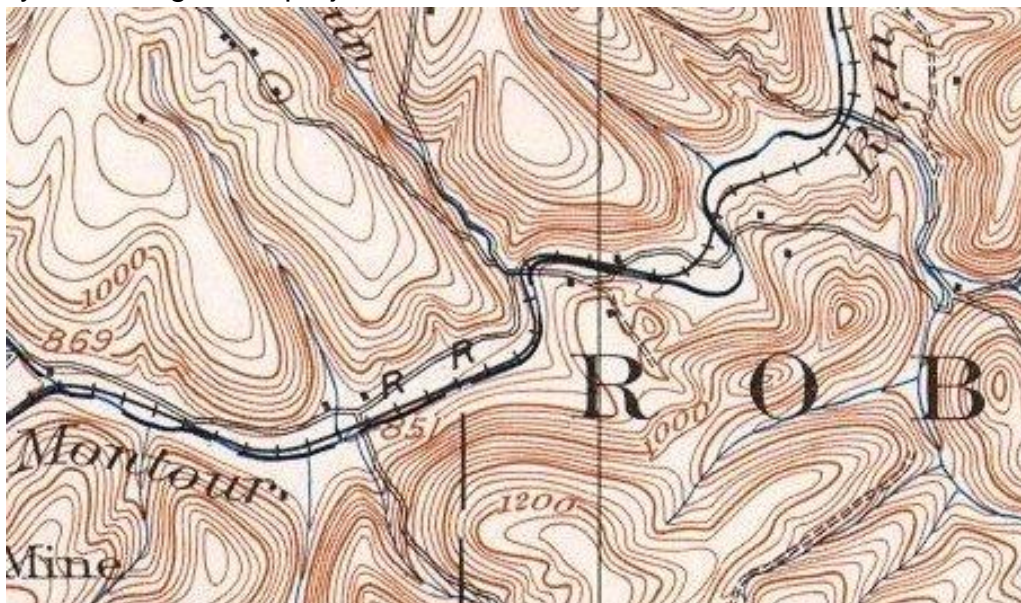
This older topo shows the original railroad alignment crossing, then following, Montour Run. In the center, just above the big “R” are the 2 sharp curves that were eliminated by the re-alignment project in 1920.

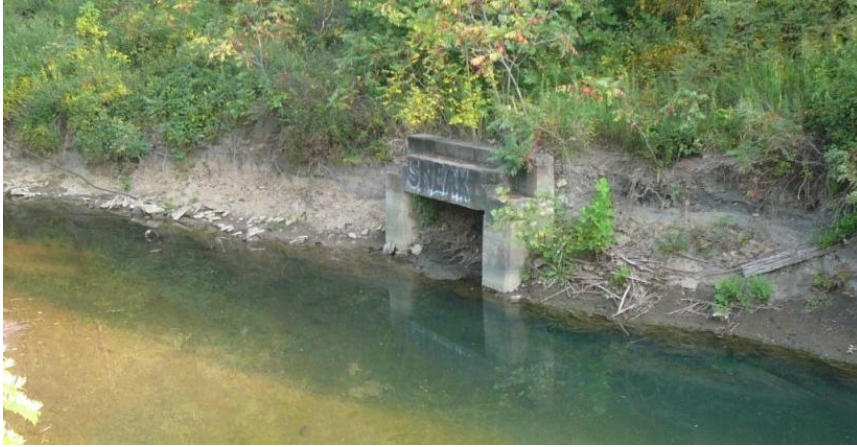
Old abutment about 100 feet northeast from bridge could have been farm road as seen in 1938 aerial view and following picture.

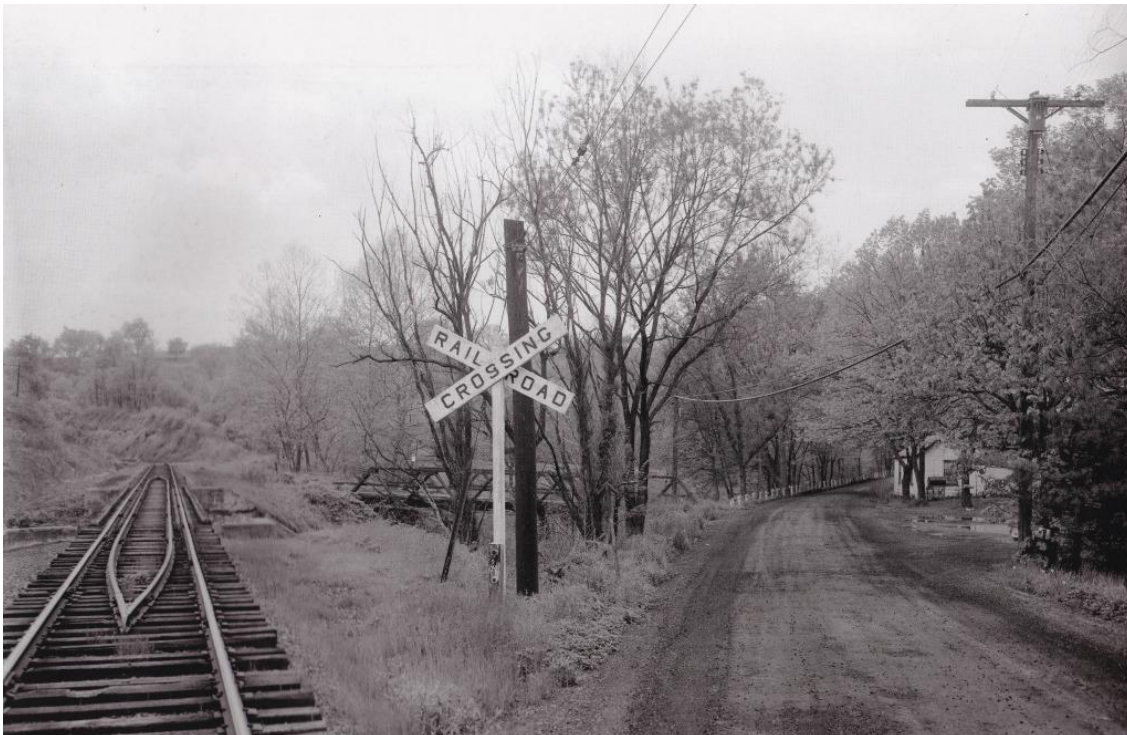
View from 1961, looking RR east, shows bridge before construction of Montour Run Road, which eliminated the road and house on the right side of the picture. Right end of pony truss road bridge is where concrete abutment still exists.
