Westland MP 2.9 24' Concrete Slab

Built in 1927 Over farm road along Hornhead Road

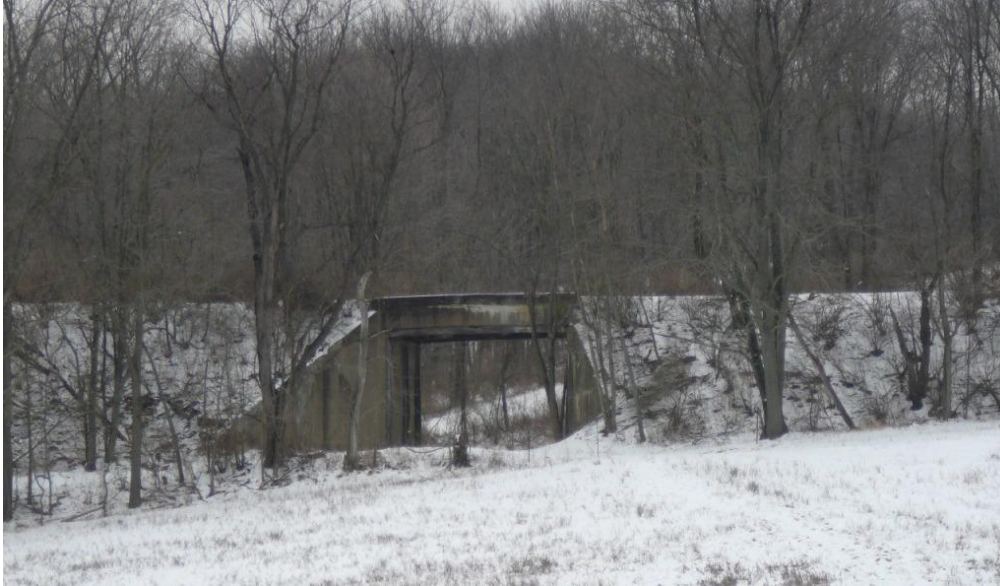
View from Hornhead Road.

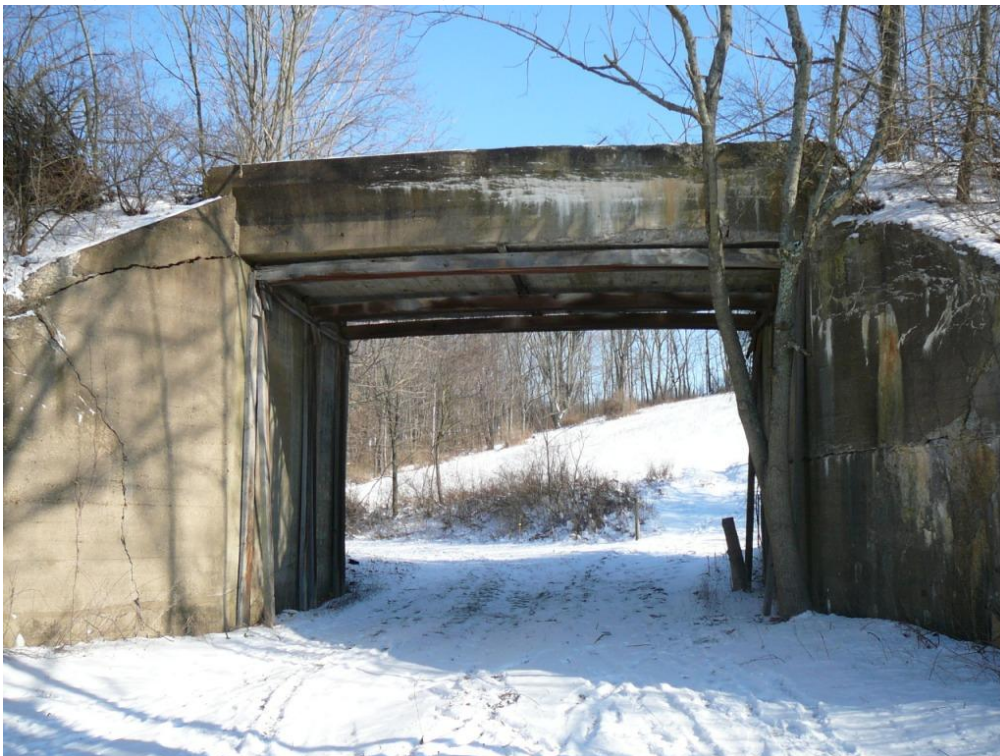
View looking east shows how bridge provided access into farm fields on opposite side of railroad. Note cracks in abutments from soil pushing against concrete. Timber bracing was applied under bridge slab to hold abutments in place.

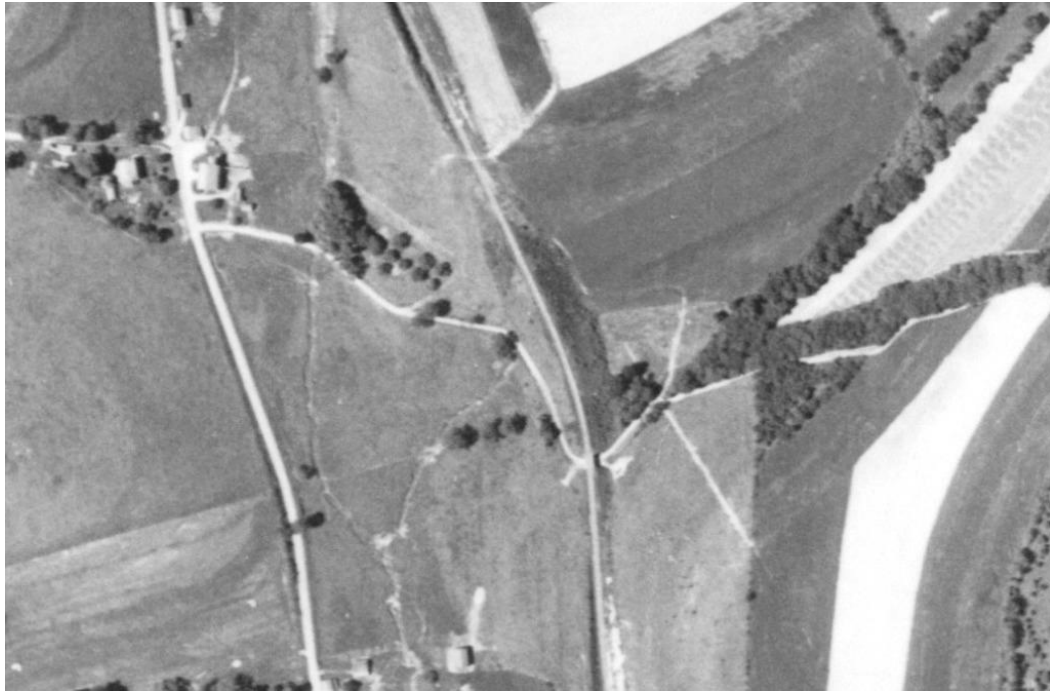
Aerial view from 1958 shows the farm road running from Hornhead Road at left, under bridge and into farm lands on east side of railroad.

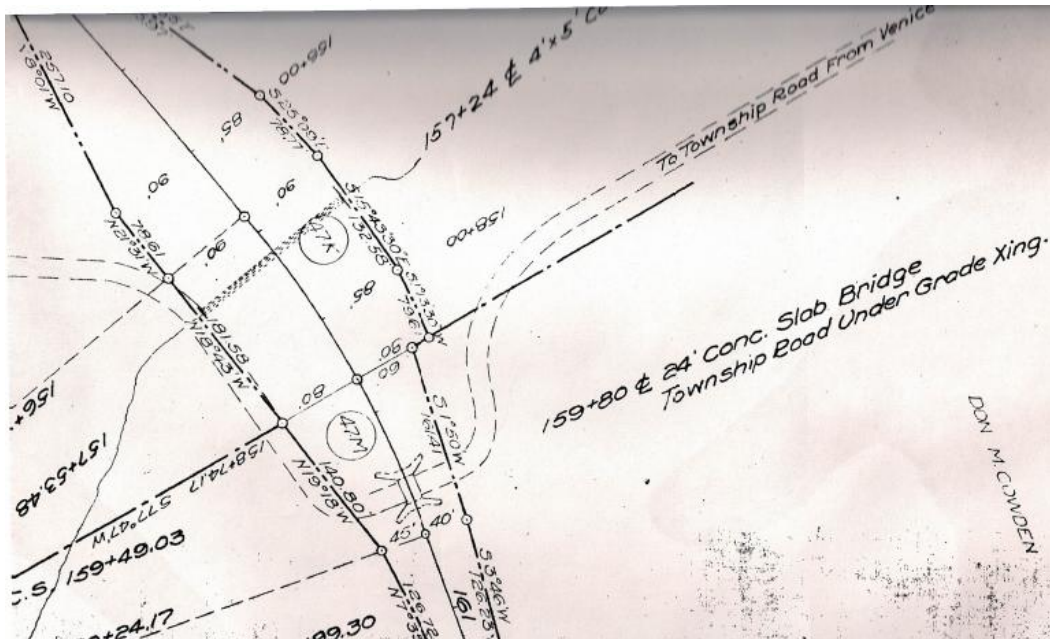
Valuation plan shows concrete slab bridge with township road crossing under railroad and continuing at upper right towards Venice.

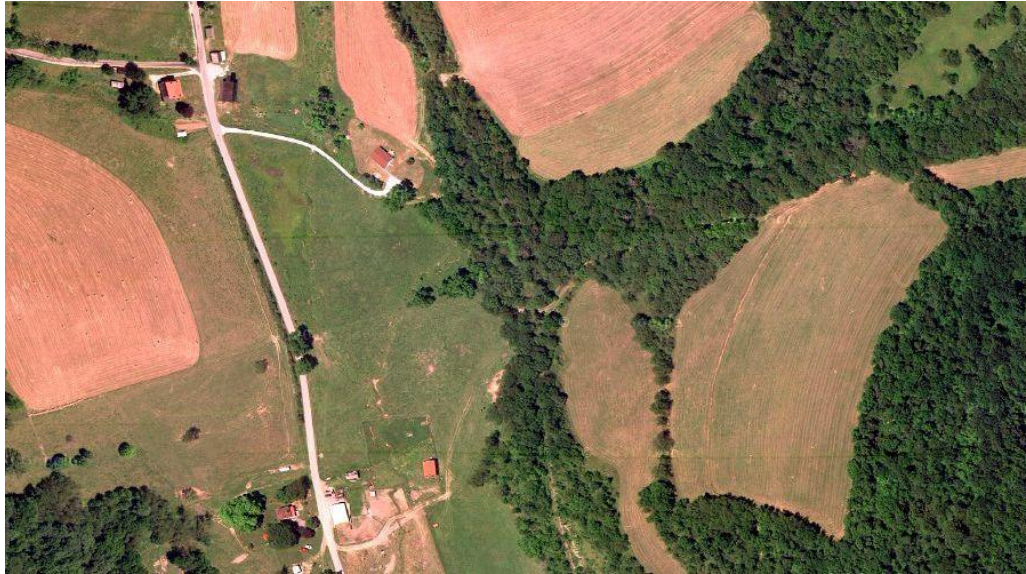
Satellite view shows bridge at center of frame, at small break in tree line. Railroad right-of-way runs top to bottom at center, with Hornhead Road parallel to left. Farm road runs past house and under railroad, along tree line, into fields on east side of railroad.

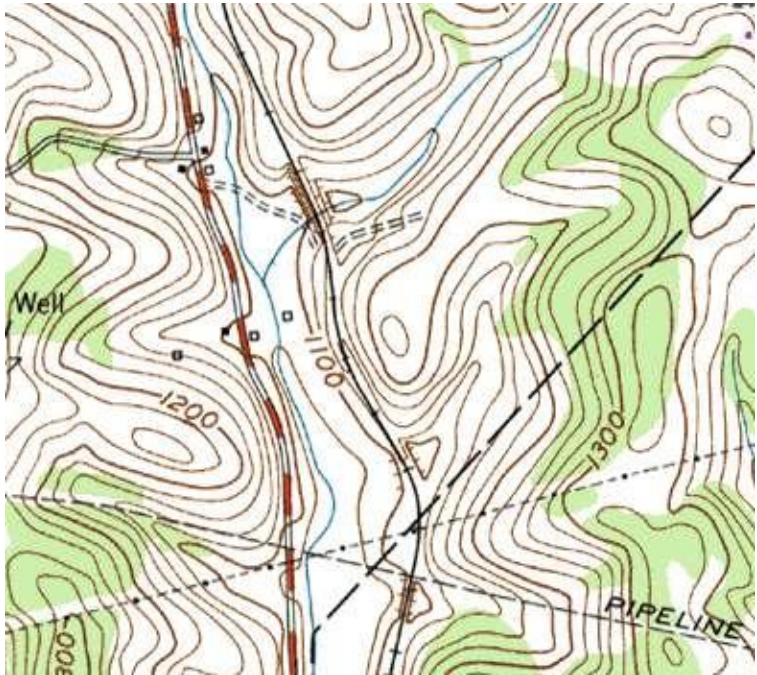
Topo map shows bridge near center, where dashed township dirt road crosses railroad. Hornhead Road runs top to bottom at left. Power line and pipeline cross railroad at bottom center.
