Westland MP 2.9 24' Concrete Slab

Built 1927 Over farm road along Hornhead Road

Removed 2012 – replaced with metal culvert access

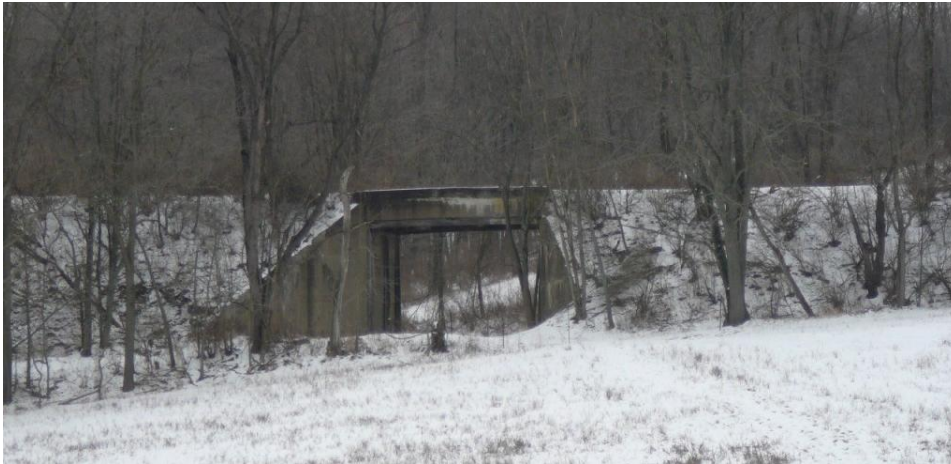
View from Hornhead Road in 2011 shows the original bridge.

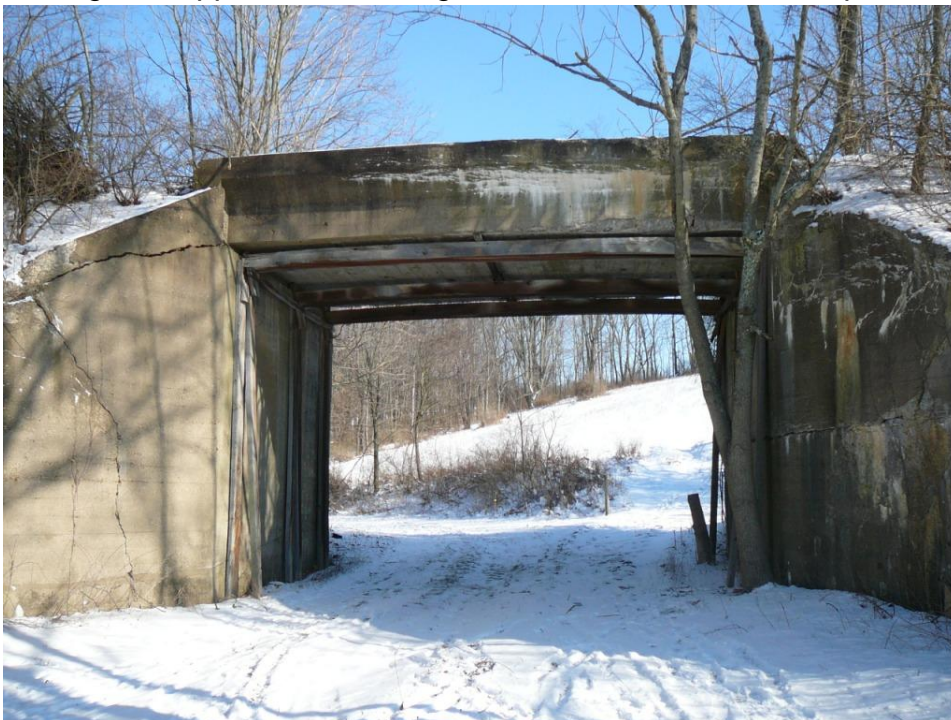
View looking east shows how bridge provided access into farm fields on opposite side of railroad. Note cracks in abutments from soil pushing against concrete. Timber bracing was applied under bridge slab to hold abutments in place.

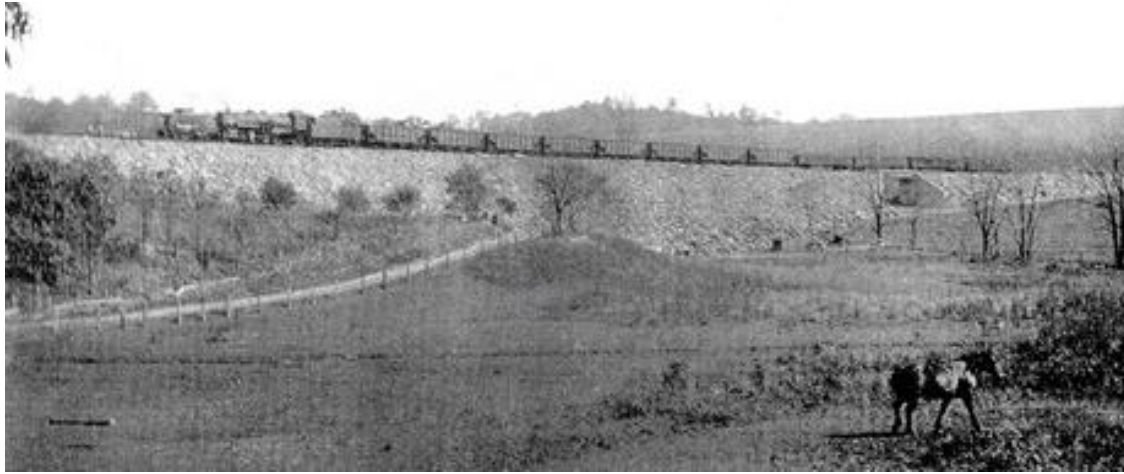
OCT 11, 1927

The first train crosses the bridge after completion of construction in 1927. The engine is shoving coal cars down the railroad toward the Westland Mine tippie.

FIRST TRAIN ON NEW RAILROAD

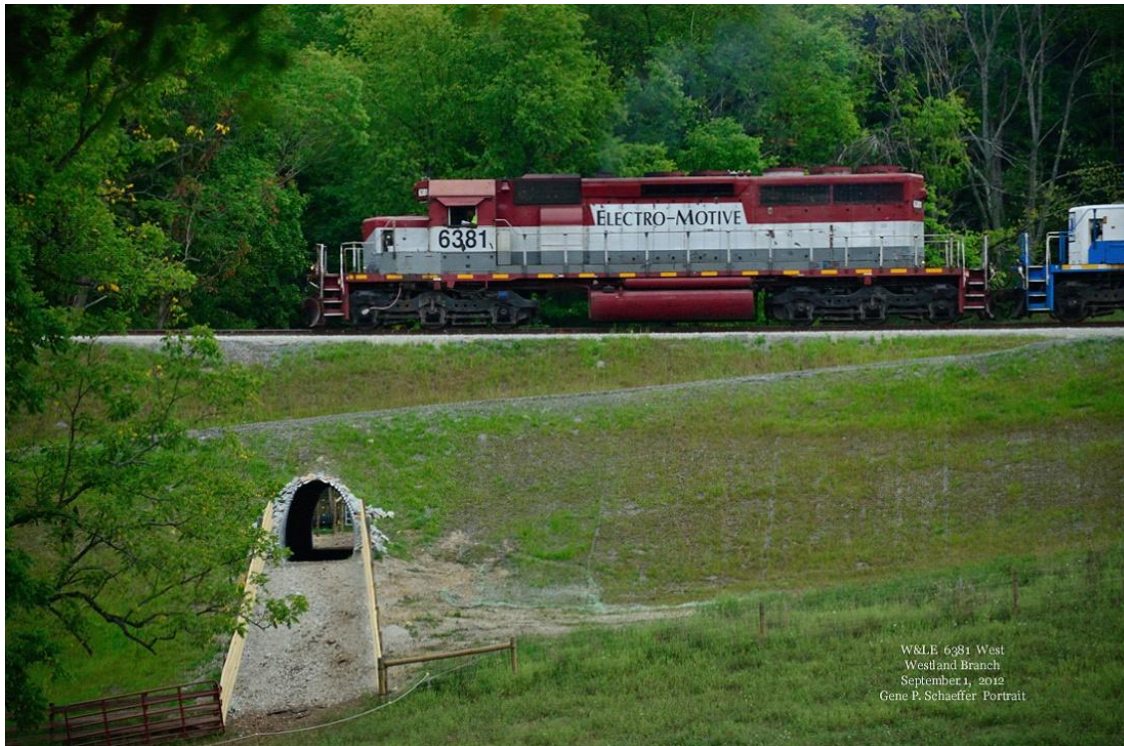
View after railroad reconstruction in 2012 shows the bridge removed and replacement culvert installed as a “cow subway” to provide access to fields on far side of railroad. Farm equipment access is maintained by a grade crossing of the railroad. The original bridge was at the right edge of this frame.

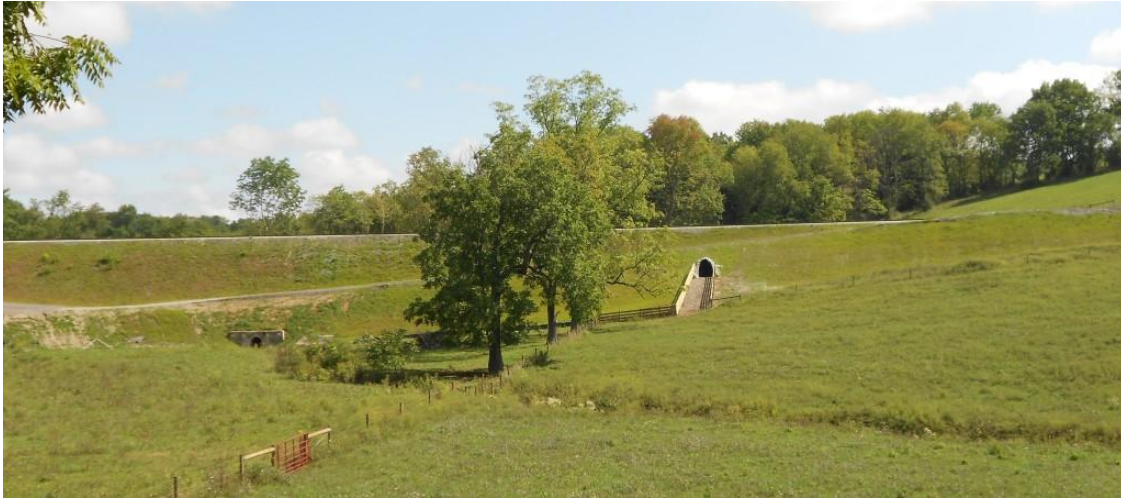
Wider view shows location of metal “cow subway” culvert. Concrete drainage culvert remains at left of big trees. Farm access road climbs the bank above culvert and cow subway to a grade crossing near right edge of frame, at location of the original bridge.

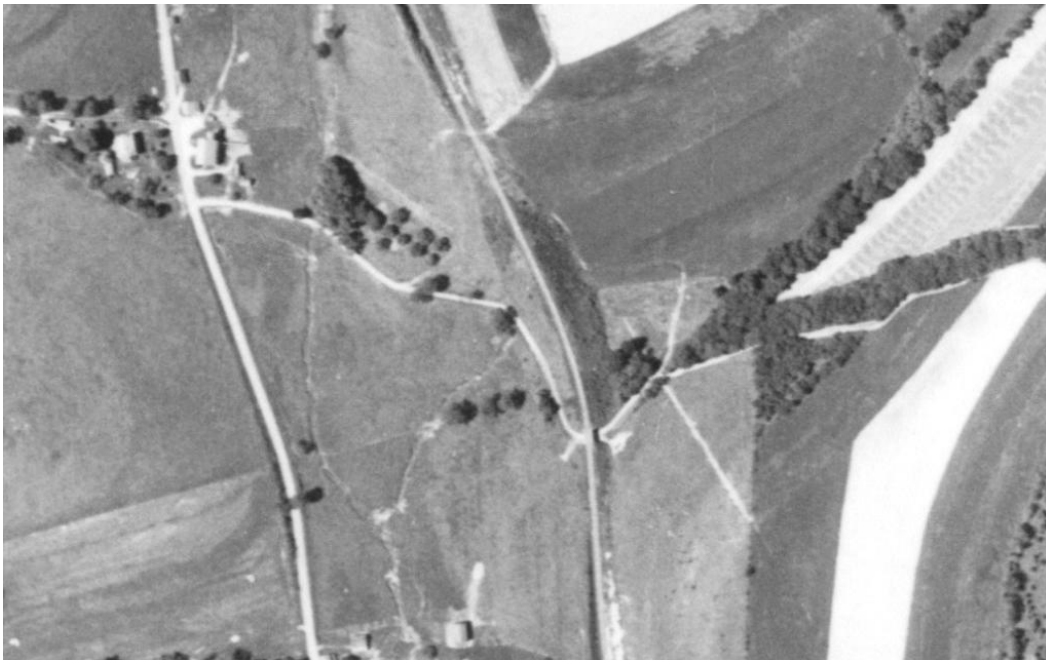
Aerial view from 1958 shows the farm road running from Hornhead Road at left, under the bridge and into farm lands on east side of railroad.

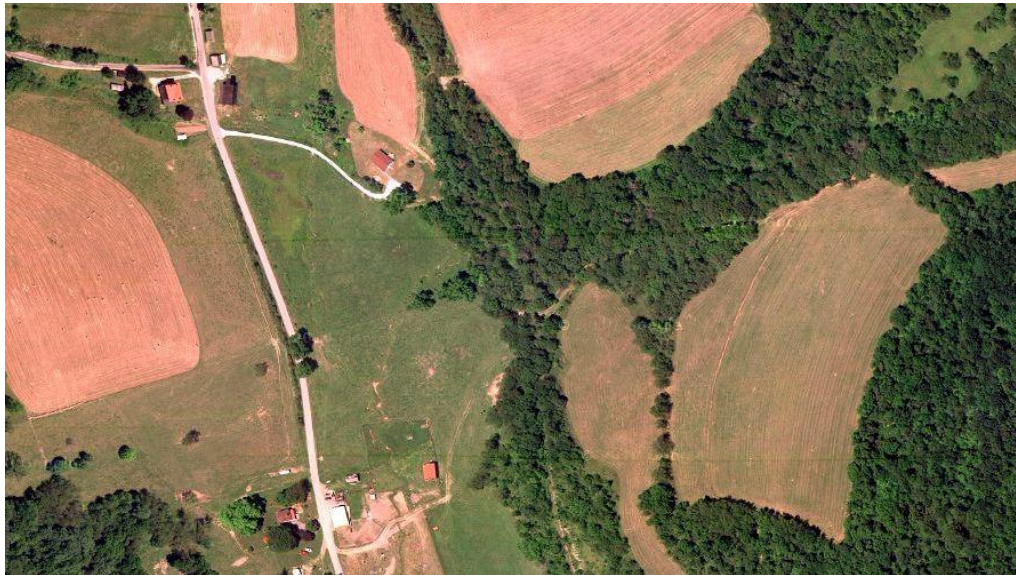
Satellite view shows bridge at center of frame, at small break in tree line. Railroad right-of-way runs in tree line top to bottom at center, with Hornhead Road parallel to left. Farm road runs past house and under railroad into fields on east side of railroad.
