National No. 3 (Bob Ciminel ©2012)

Continuing eastward past Cowden Siding, we come to Muse Junction and the Muse Spur, built in 1921 to serve the National Mining Company's National No. 3 Mine (National Mining was a subsidiary of the United States Steel Company). National Mining owned and operated National No. 3 until December 29, 1942 when the deed was transferred to the H. C. Frick Coke Company, which operated the mine until at least 1947. When the mine closed in 1955 it was owned by U.S. Steel, but when it was transferred from Frick to USS is not known.

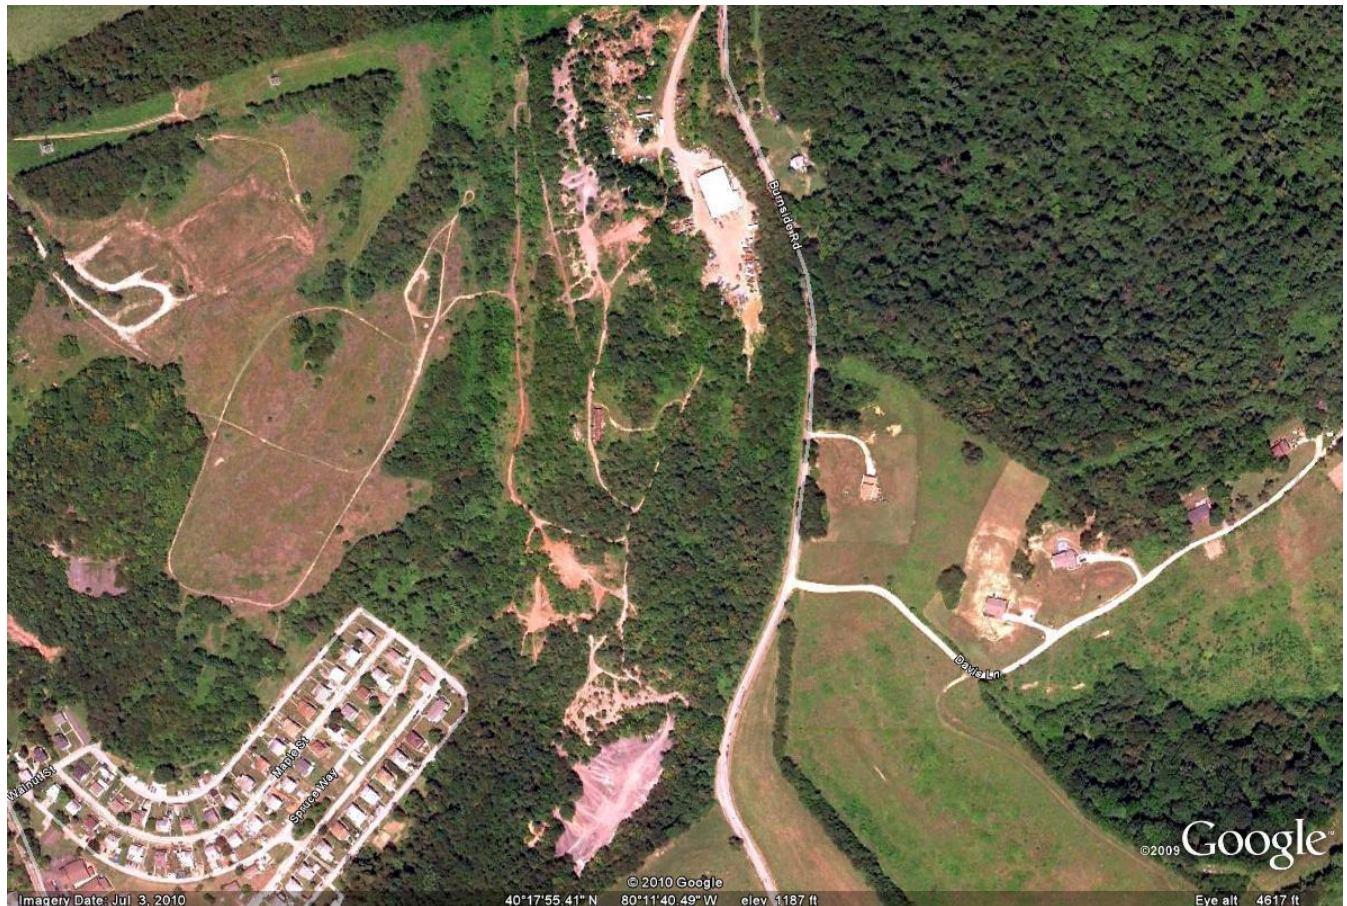
The site of National No. 3 in 2010 with the community of Muse at the lower left. One of the mine's waste dumps is visible at bottom center.

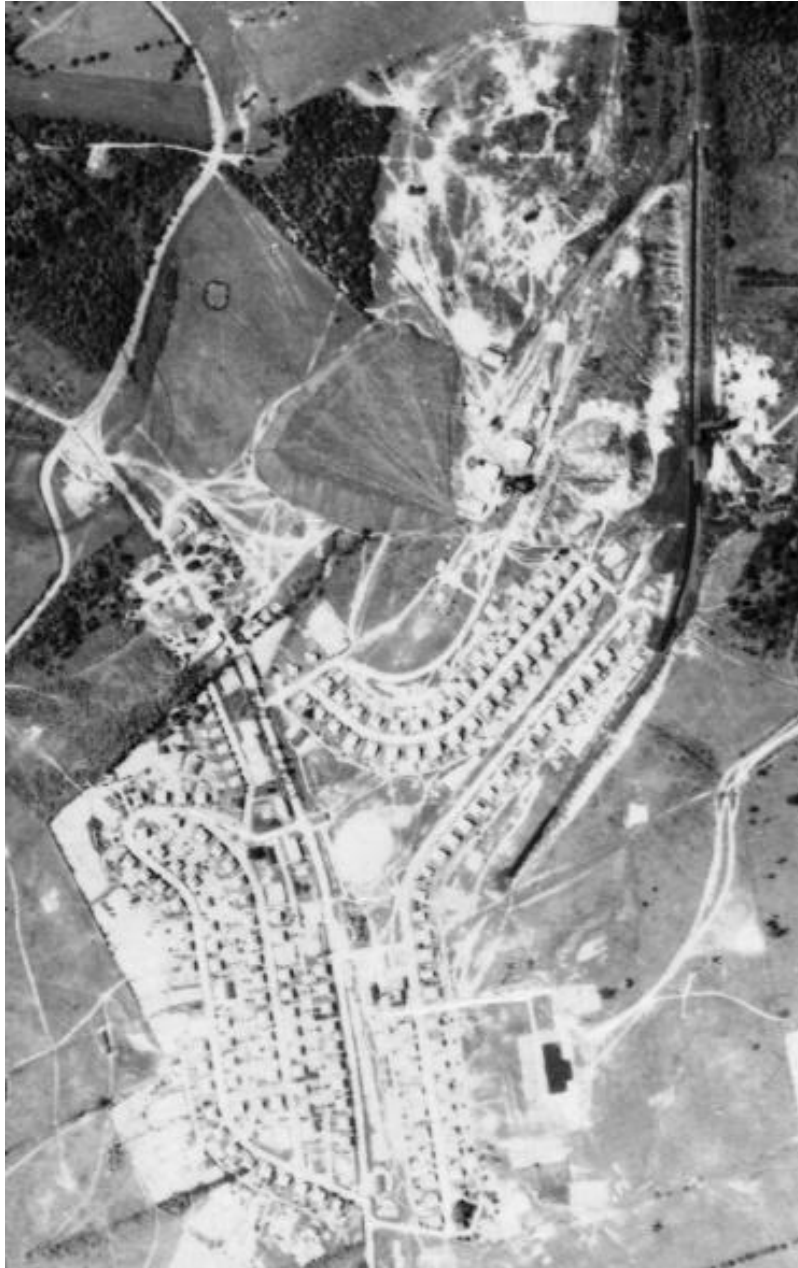
This 1939 aerial view shows the coal tippie on the right and the waste hoist to the right of the waste pile. Note how far the tracks for the empty yard extend beyond the tippie; an indication of the large amounts of coal that were shipped from the mine.

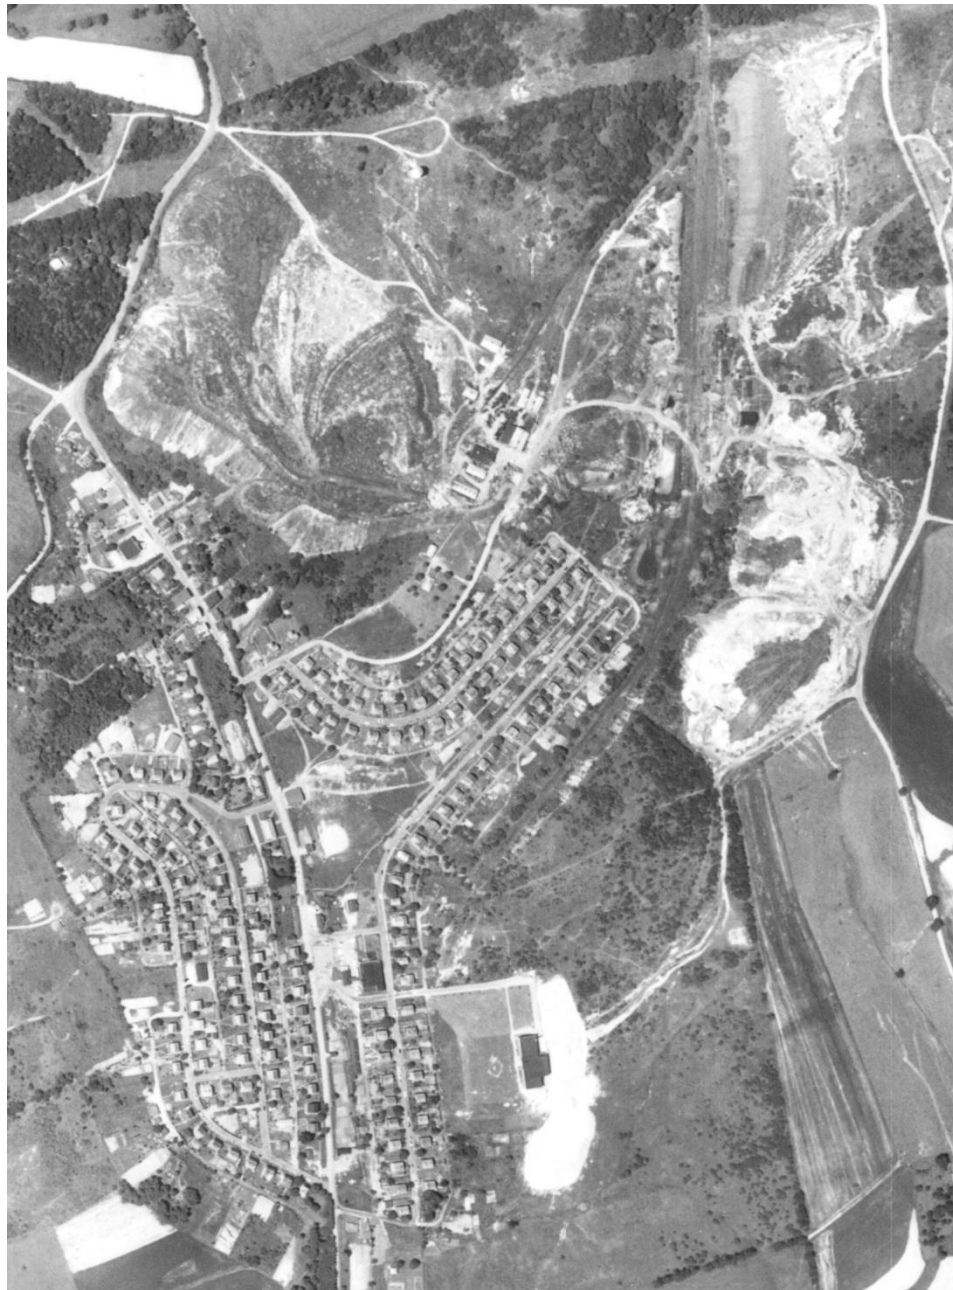
This 1958 view was taken after the tippie was dismantled. The buildings to the right of the waste pile indicate that the old mine site was still being used for light industry. Note that the Montour tracks appear to be still active in that area.

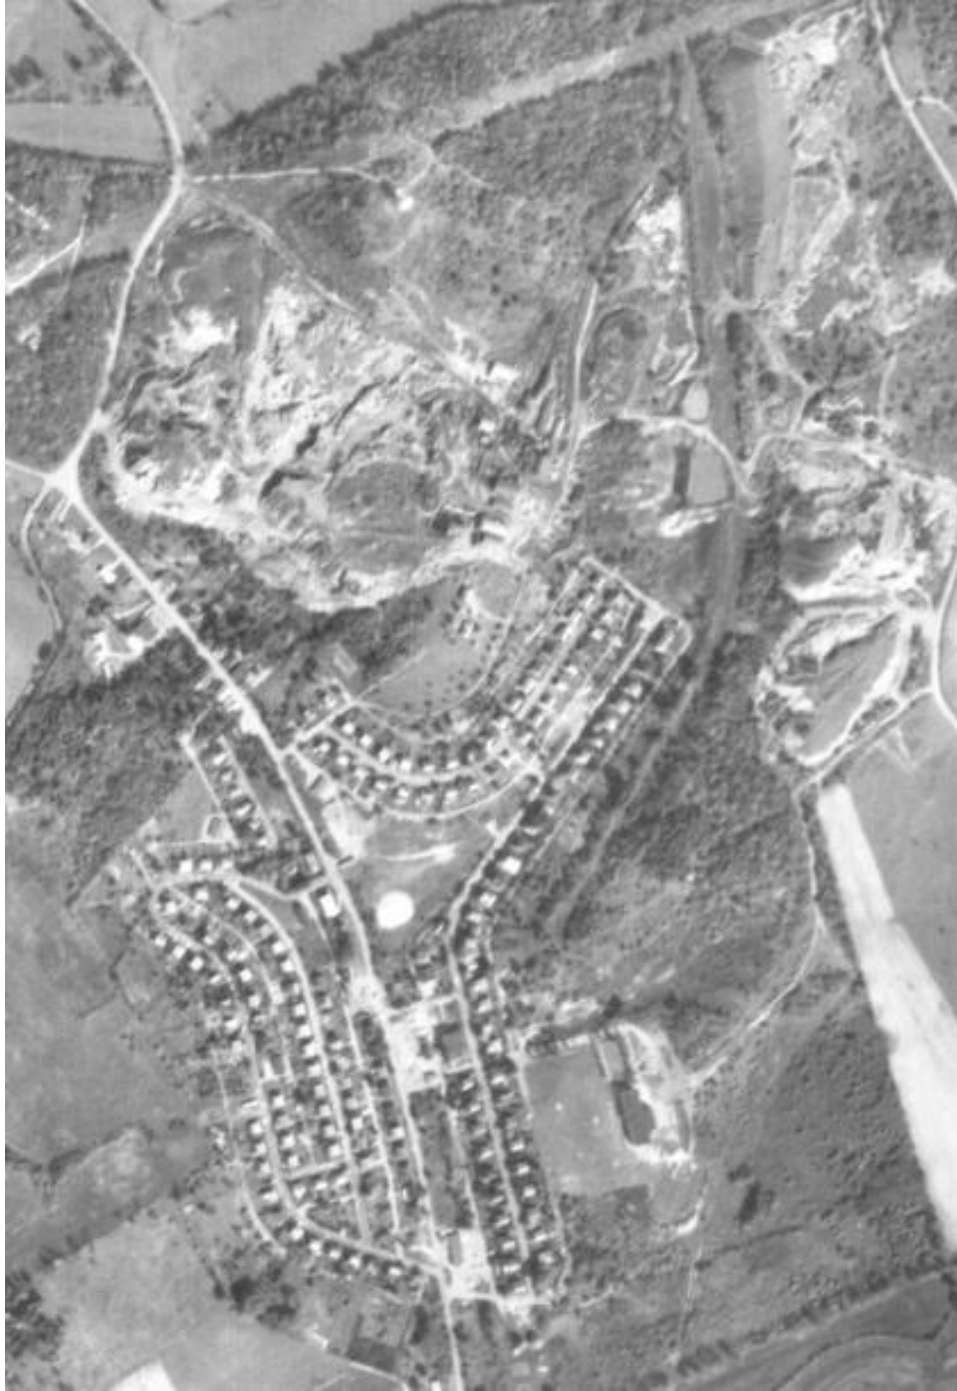
This 1930s era WPA maps shows that the coal seam dipped upward from 810 feet to 900 feet as the National No. 3 workings extended to the west. The unmined area on the left parallels Route 980. Why that coal was left there is a mystery.

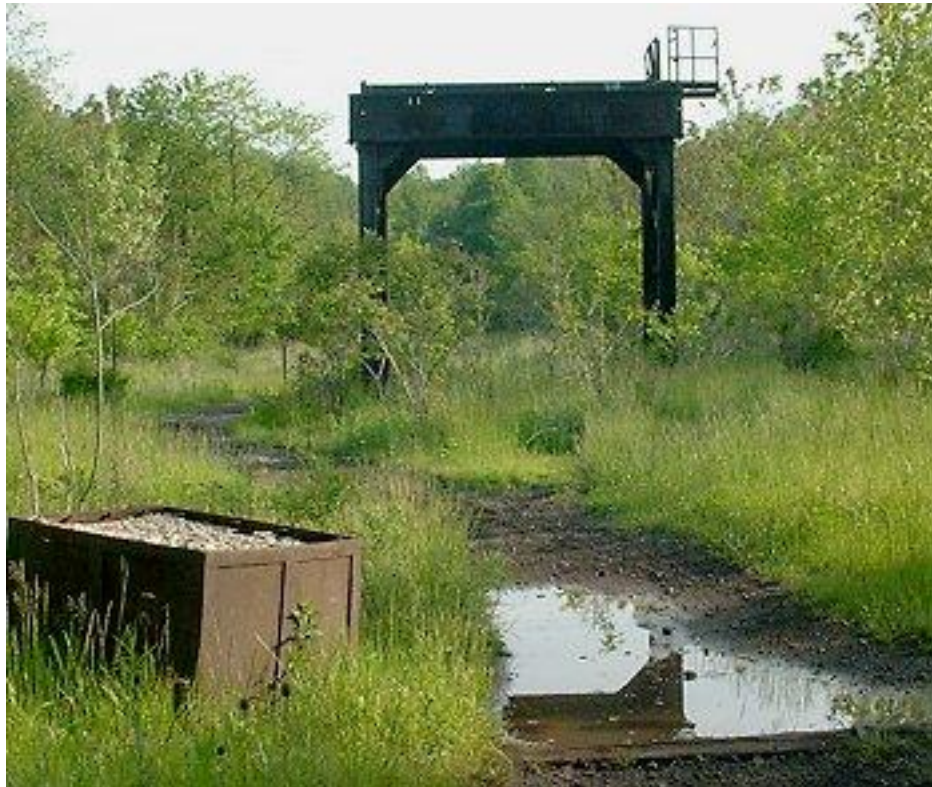
This is a photo of the ruins of Montour No. 3.

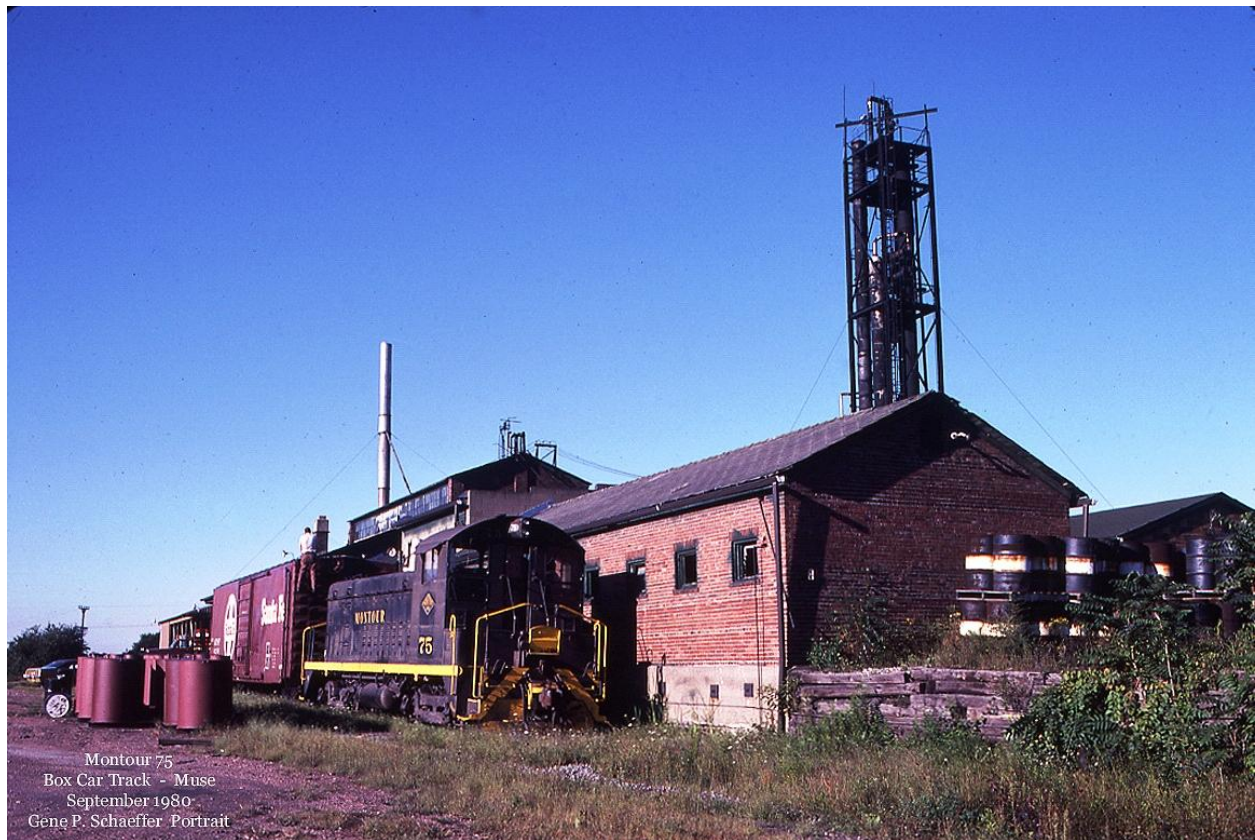
Montour 75
Box Car Track - Muse
September 1980
Gene P. Schaeffer Portrait

In September 1980, Gene Schaeffer photographed a Montour crew servicing the Chemicals & Solvents Company facility on the old National No. 3 site. The Montour had two tracks at this location, one for box cars shown here and another for tank cars behind the brick building.

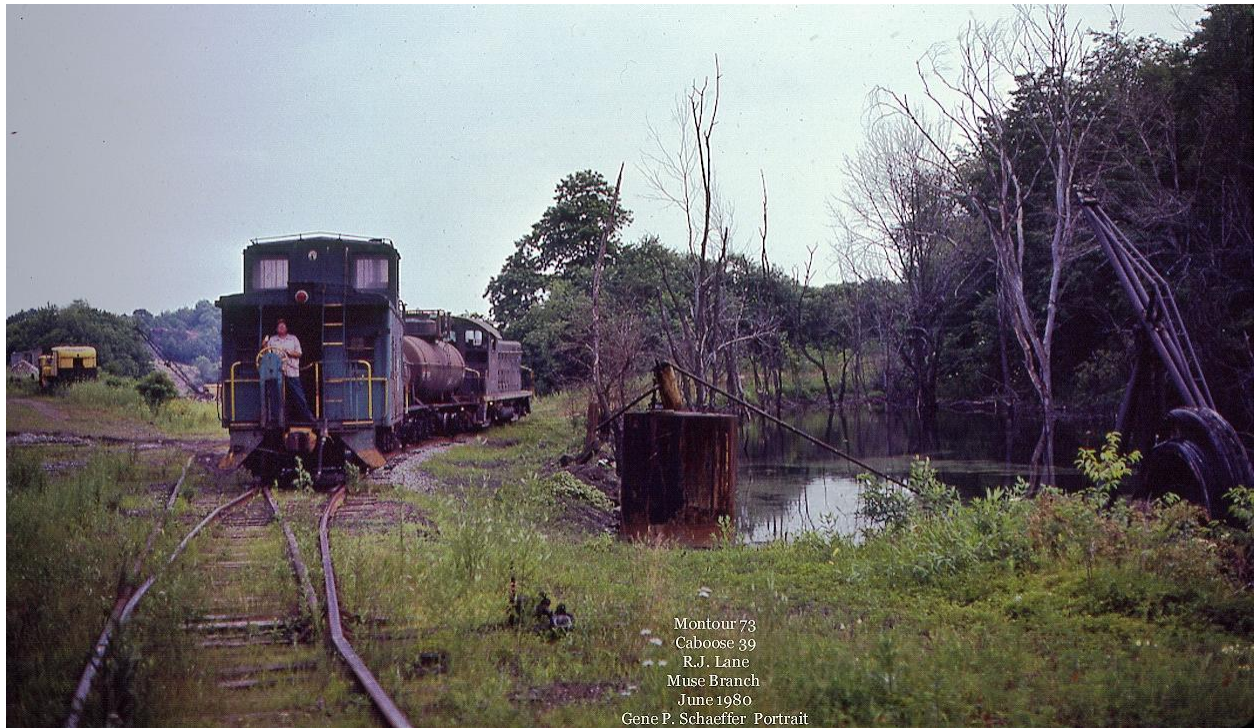
Montour 73
Caboose 39
R.J. Lane
Muse Branch
June 1980
Gene P. Schaeffer Portrait

Another photo by Gene Schaeffer taken in June 1980 shows a Montour crew departing the C&S spur on its way west to Muse Junction. Montour engineer R. J. Lane is standing on the caboose while P&LE engineer Jim Stanley exercises his seniority rights by in SW9 #73. Note the old oil well storage tank and pump jack on the right.
