As we continue eastward from Montour No. 4, we reach Library Junction at Mile post 35.08. The west leg of the wye takes us onto the Library Branch. After crossing Library Viaduct we reach Montour No. 10 Mine at the bottom of the hill on the north side of Brownsville Road.

Montour No. 10 is another mine with a long and varied history that came to a close in 1979. The mine started life under a different name that coincided with the completion of the B&O's Pittsburgh-Wheeling route through Broughton in 1883. Shortly after the line opened, the Keeling Coal Company began developing the Lick Run Mine in the coal outcrop on the west side of the B&O line going down Lick Run to Snowden.

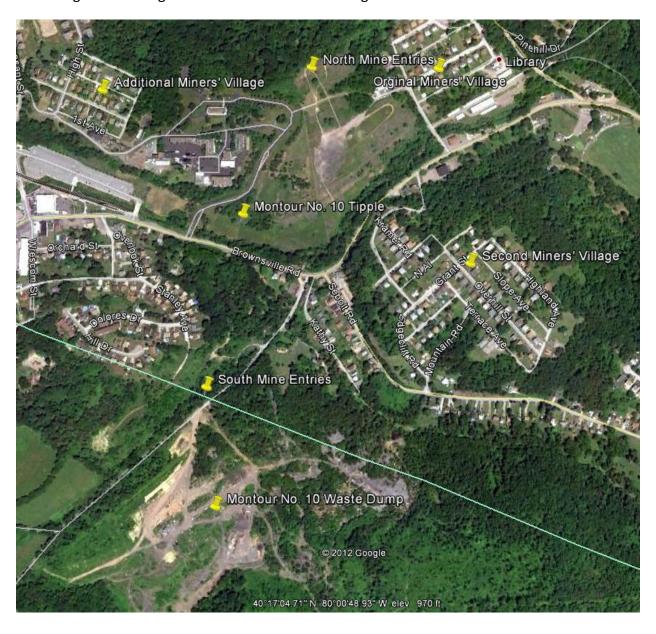
This Google Earth image shows some of the remaining features of Montour No. 10 Mine.

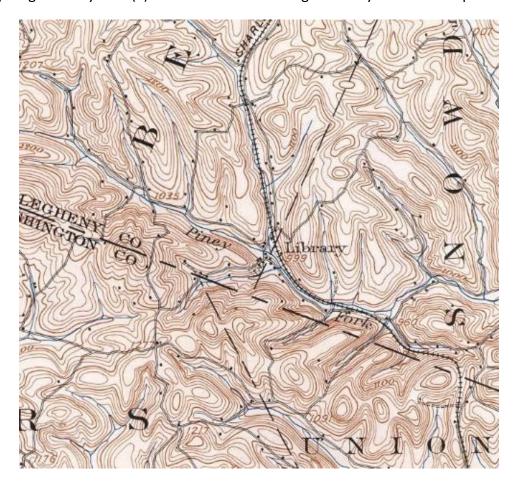
This 1906 topographic map shows the Library area before the Montour Railroad Library Branch was completed. The Charleroi interurban line is now used by the Port Authority of Allegheny County's Light Rail System (T) Blue Line from Pittsburgh. Library is the last stop on the route.

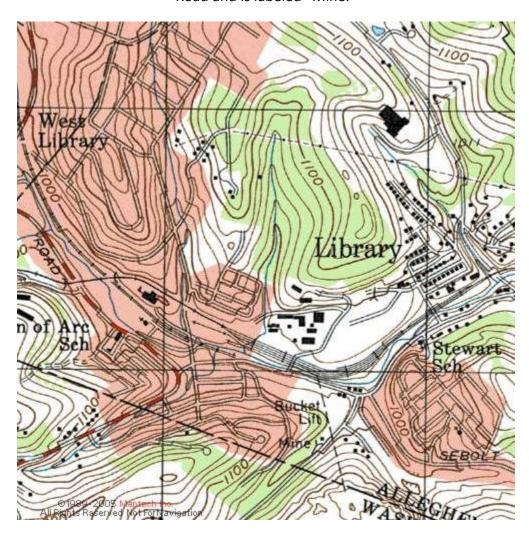
This topographic map shows the two drift entries and waste tramway used by Montour No. 10. The north entry is located below the word "Library." The south entry is located along Cardox Road and is labeled "Mine."

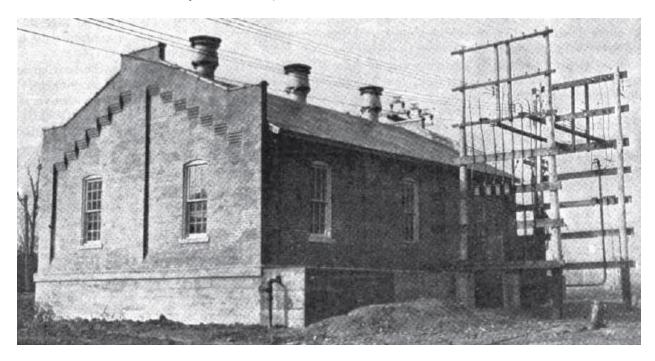
This photograph from 1922 shows the electrical substation at Montour No. 10 and was used to illustrate how many mines were switching to purchased power from the local utility instead of generating it on-site. The Pittsburgh Coal Company was a major investor in the West Penn Power Company and converted all of its mines to off-site power. The transmission lines the Coal Company had originally installed between its mines (many mines received power from adjacent mines) were sold to West Penn Power.

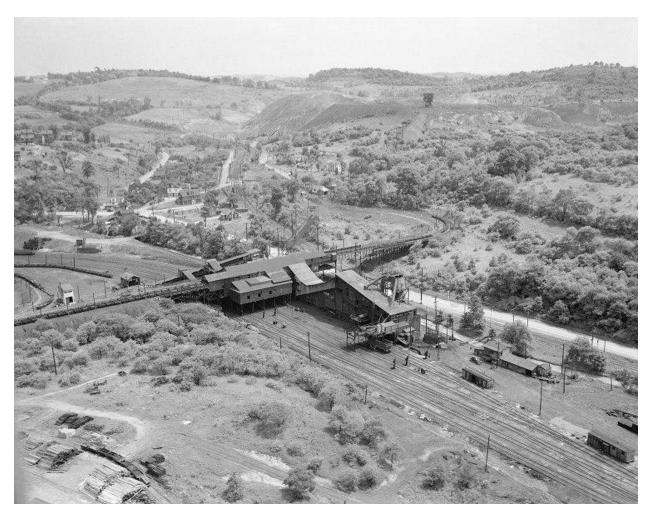
This 1946 aerial photo was taken by the Pittsburgh & Lake Erie Railroad after it became a 50% owner of the Montour Railroad along with the PRR. The view is toward the southeast and shows the mine tracks curving around the hill to reach the southern portion of the mine. The dumping station on the waste pile is also visible. Note the pile of mine props and mine cars in the lower left and the tracks coming from the northern entry at center left. The additional coal processing section on the right side of the tipple was the Champion No. 3 cleaning plant.

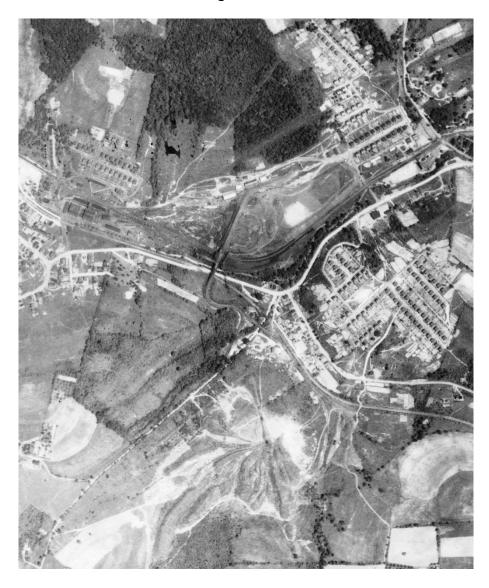
This 1938 aerial photo shows the tipple and mine tracks for No. 10 along with the various miners' village associated with the mine. Note the strings of hopper cars in the empty yard waiting to be loaded.

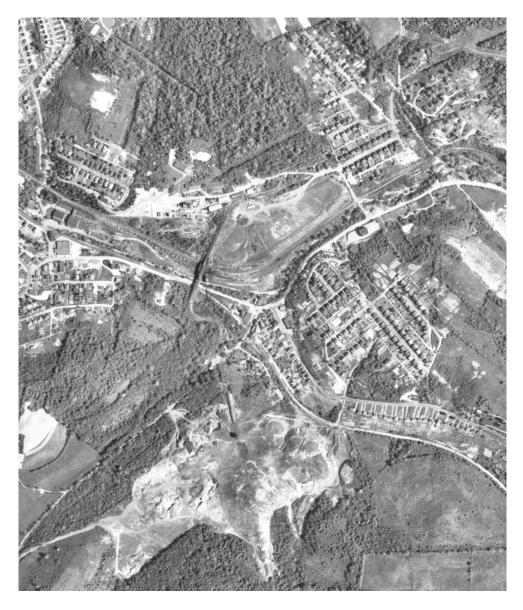
Montour No. 10 was close when this 1957 photo was taken (no coal cars in either yard), but was obviously not abandoned because the tipple was not razed. The coal cleaning plant has also been removed from the western side of the tipple.

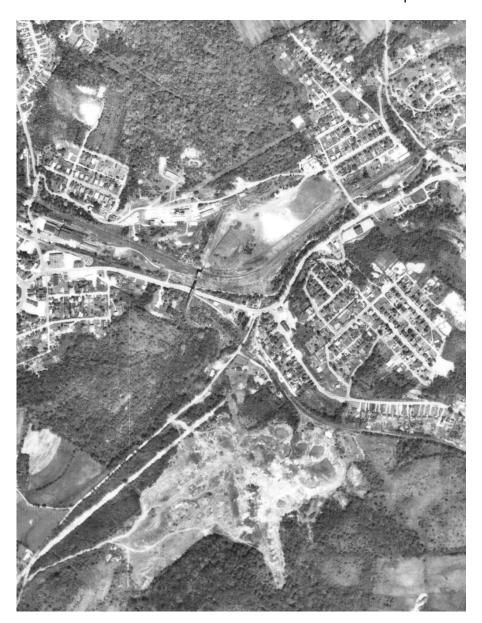
The mine is still closed in the this 1967 photo, and it looks as though they are scavenging waste rock from the southern section of the old mine dump.

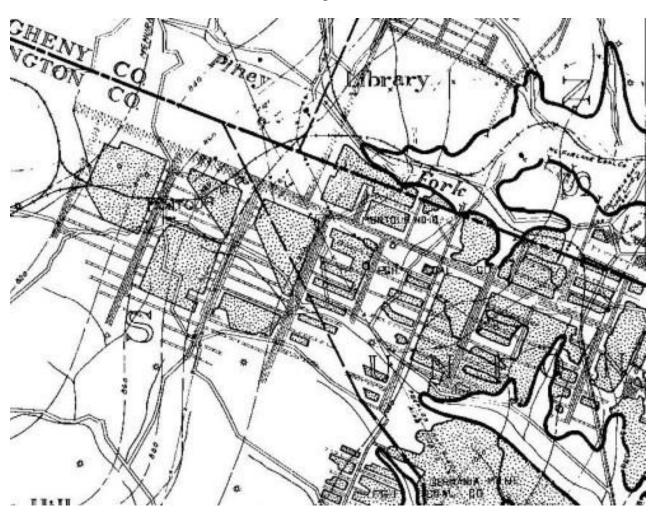
This 1930s era mine map shows the extent of the southern section of Montour No. 10. Recall that the northern section was mining coal in the old Lick Run Mine area.

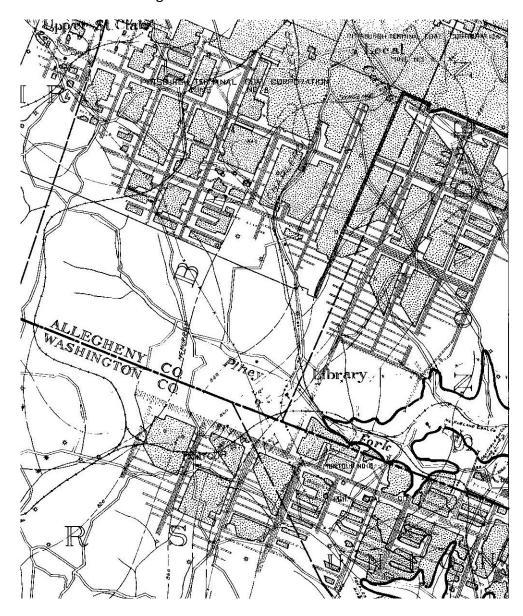
This larger map shows the northern section of Montour No. 10. The heavy black line is the barrier pillar between Montour No. 10 and Coverdale No. 8 Mine on the northwest and Pittsburgh Terminal No. 4 Mine on the northeast.

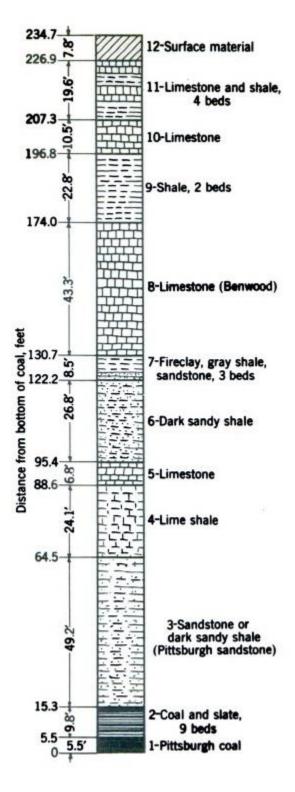
This diagram shows the overburden and strata above No. 10 mine. The average depth was about 230 feet from the bottom of the coal seam to the surface. However, as stated earlier, there was a point beneath South Park where the seam was only 40 feet below the surface. The 5.5-foot Pittsburgh coal was what the miners at No. 10 were after.

Montour No. 10 was unique among the mines along the Montour Railroad because it mined both sides of the Pittsburgh Seam along Piney Creek valley. Montour No. 10 was on the western edge of the Amity Anticline (a subterranean hill) and the Pittsburgh Seam rose from 860 feet above sea level at the mine's western boundary to over 1,050 at its eastern boundary. The Montour No. 10 tipple was built over the railroad right-of-way at 860 feet above sea level, but the coal seam was 140 feet above the valley. This difference in elevation required the mine trains to travel on trestles to reach the tipple. It also allowed water to drain from the mine instead of being pumped. The valley formed by the McMurray Syncline and the hill formed by the Amity Anticline are why Montour No. 4 was a shaft mine and Montour No. 10 was a drift mine although they mined the same coal seam and abutted each other.

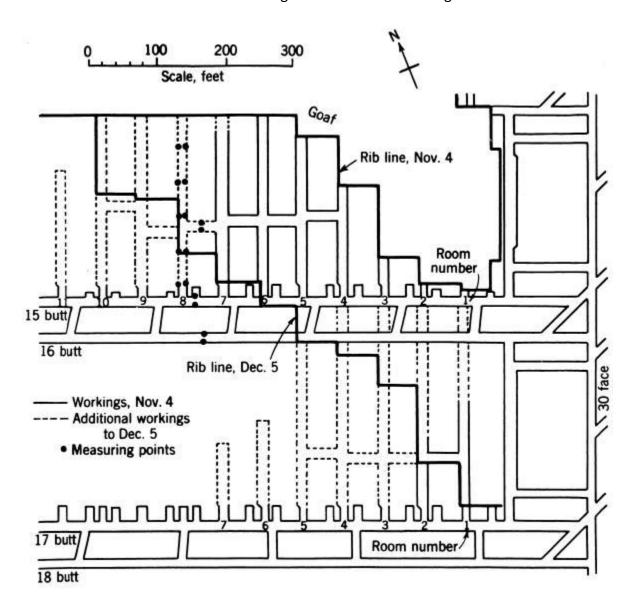
This diagram shows the mining layout at No. 10. Four face entries were driven in a north-south direction. Butt entries were driven in an east-west direction to create blocks of coal 300 feet wide and 2,000 feet long. Rooms 15 feet wide were then driven along the east-west axis to remove the coal. Once the rooms were mined, the pillars were extracted in a diagonal direction leaving a rib about 950 feet long.

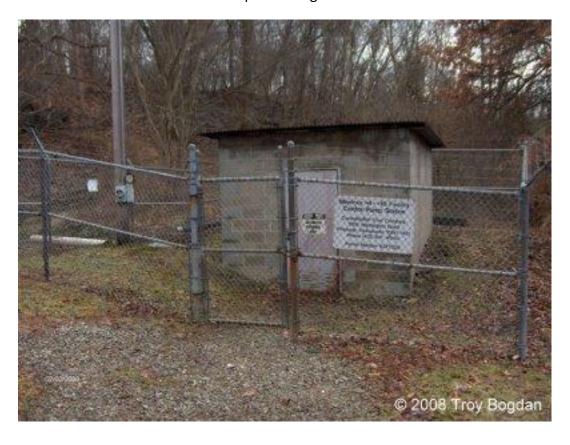
This is the pumping station for the Montour No. 10 Mine treatment plant off of Cardox Road. About 20% of Montour No. 10 is flooded, with the water level in the mine being maintained by the Hahn AMD plant along Chartiers Creek.

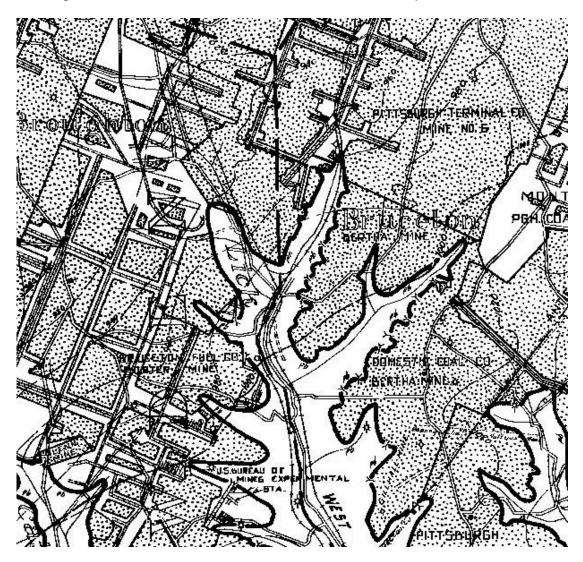
This map shows the Lick Run Section of Montour No. 10 near Broughton. The Lick Run Mine fire began about ½ mile north of the U.S. Bureau of Mines Experimental Station.

Before moving on to the details about Montour No. 10, we close the history of the Lick Run Mine on a sad note. In the spring of 1930, a farmer was burning a pile of brush in a sinkhole on his property. Unfortunately, the sinkhole was a collapsed section of the original workings of Lick Run Mine and the brush ignited the coal remaining in the pillars that after the mine was abandoned. The fire spread to adjoining farms and the farmer became so distraught that several weeks later he tied explosives around his waist and blew himself up near the sinkhole. The fire smoldered for 14 more years before the Bureau of Mines began efforts to extinguish the fire using barriers and excavating the burning coal. A map of the mine fire is included in this article.
