Montour Mine #10 – 100th Anniversary

By Bryan Seip - Montour Railroad Historical Society

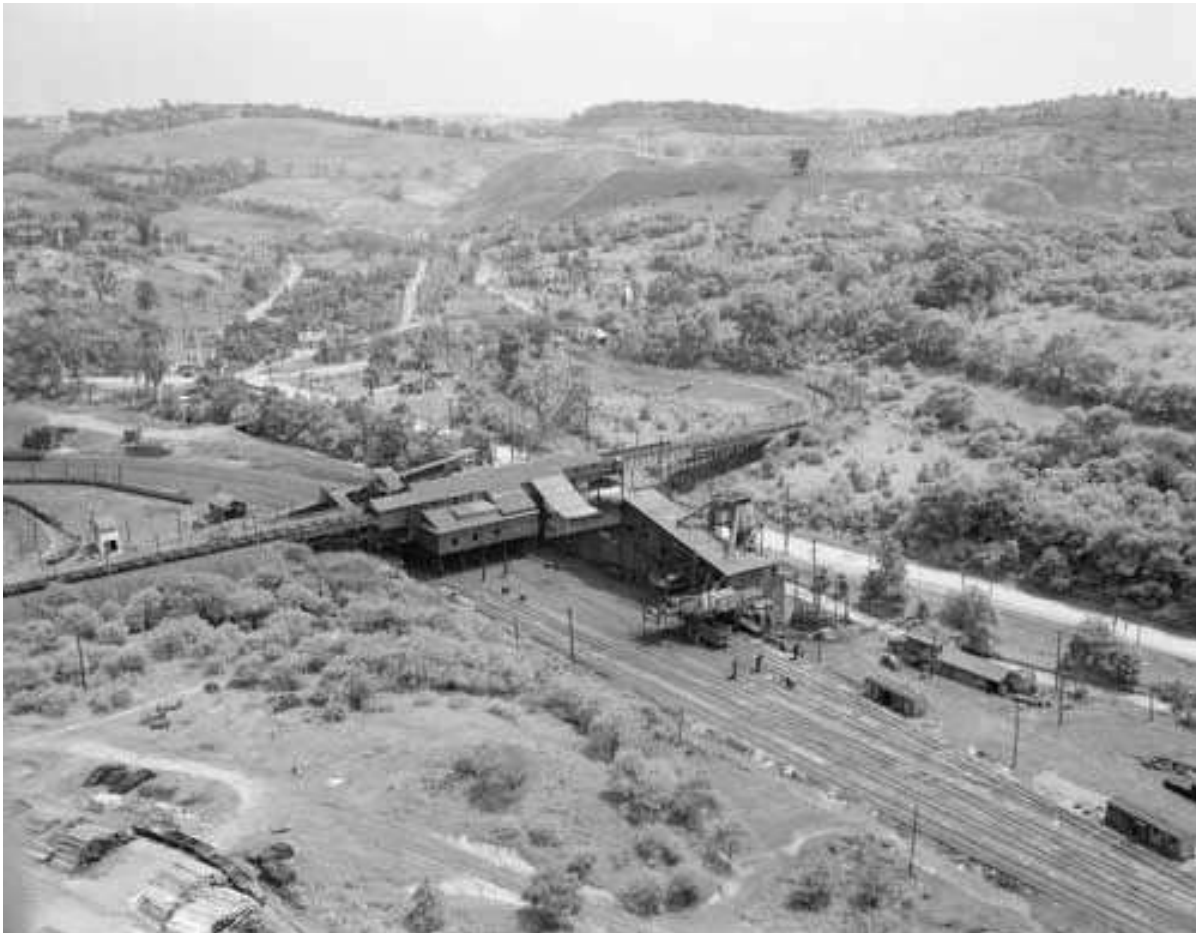
An aerial view of Montour Mine #10. Brownsville Road runs across the middle of the picture and the mine tracks are seen crossing the top and on either side of the tipple building. To the lower right of the tipple is the empty yard where empty hoppers were staged to be loaded and the loaded yard runs to the left. In the upper center is the slate dump.

The mine railroad came from the access portals across wooden trestles to the top of the tippie building where coal was dumped for sorting and cleaning before loading into railroad hopper cars for shipment. Overhead cable supported lorry cars carried waste slate and rock to a dump on the hillside across Cardox Road.

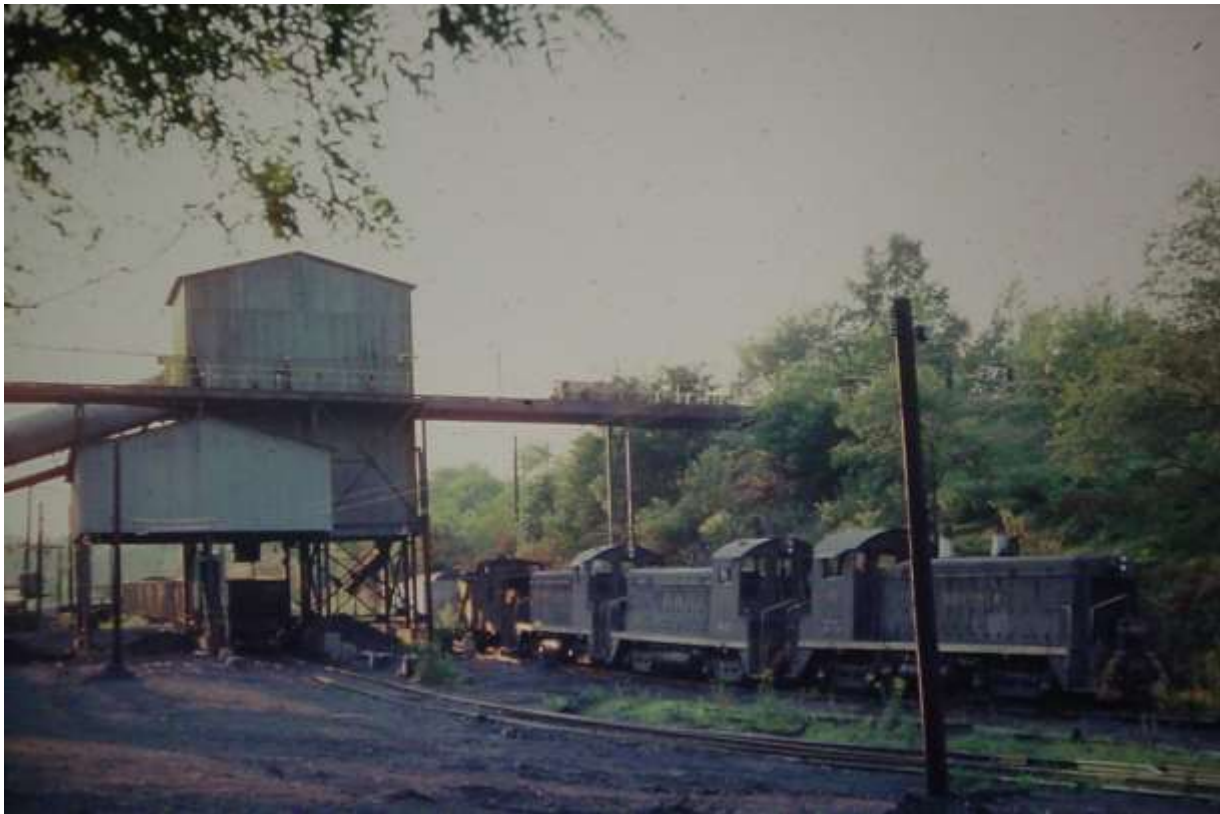
In the 1960's, the cleaning plant was eliminated and a smaller tippel was built to load coal when the mine reopened in 1970. The mine rails are still evident on the overhead trestle leading into a dumping shed. Gene P. Schaeffer photo.
