MP 21.2 Peacock Tunnel Curved Bore

Mile 20.2 Trail MP 19.2

Bored 1913 Daylighted circa 1918-19

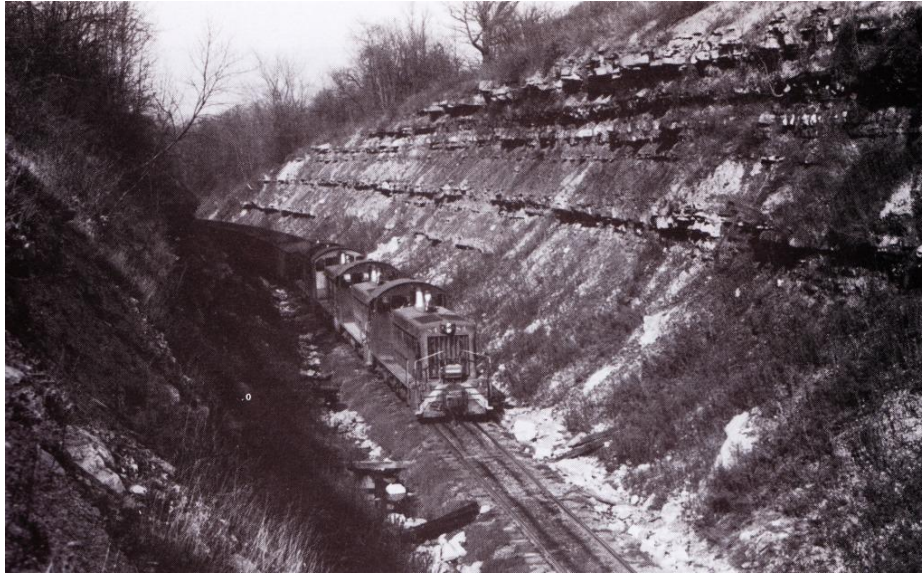
A train of empty hoppers is eastbound through Peacock Cut in 1979. Originally bored as a tunnel, the cut was later daylighted, due to instability of the rock and surrounding ground which caused water leaks and rock falls inside the tunnel.

"A tunnel located West of Peacock was daylighted due to the instability of the terrain"...

When engineer Jim Lane first started on the Montour Railroad in 1936, he recalled seeing relics of tunnel timbers lying west of the cut at Peacock, on the high side. He told me the hear-say was that Peacock was a "wet" tunnel. It was the standard timber framed, wood lined type, but the ground was too soft, and combined with the seepage, created a lot of collapsing within the tunnel.

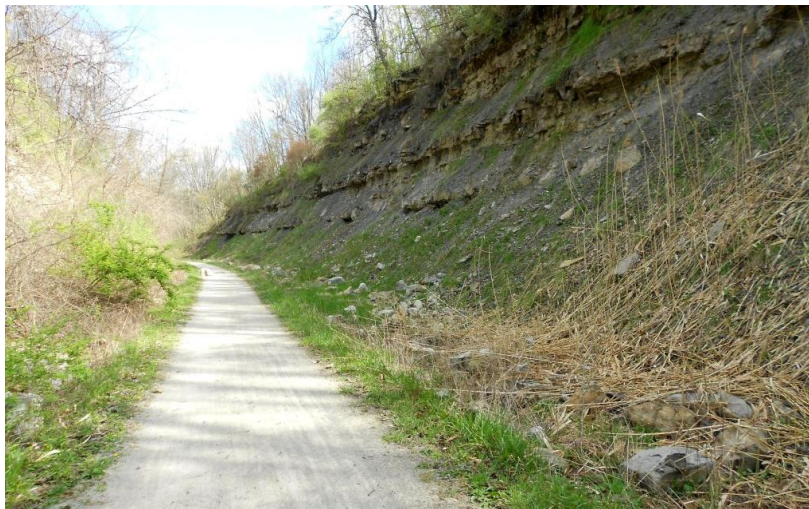
A 2012 view shows the Montour Trail through Peacock Cut. Water and rock fall are still issues that must constantly be dealt with on this section of Trail. A study of the cut, trail and topo maps show that the tunnel was a curved bore of approximately 600 feet.

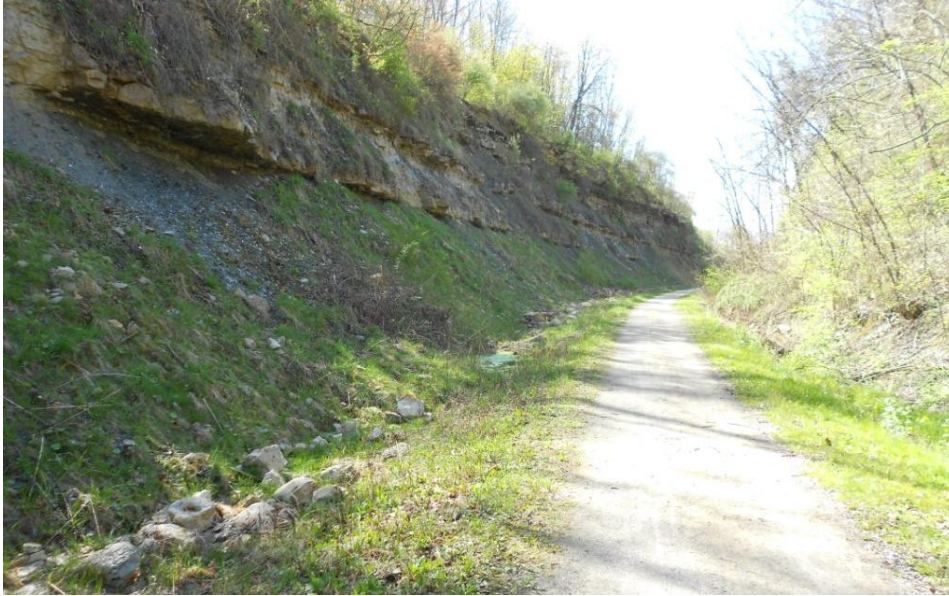
Looking east into Peacock Cut, in 2012, shows a large amount of rocks lying along the bottom of the cut. At times, rocks falling off the hillside will roll onto the Trail surface.
